Bauneg Beg Conservation Tour Sunday August 31, 2003

Agenda/Tour Stops

Introduction

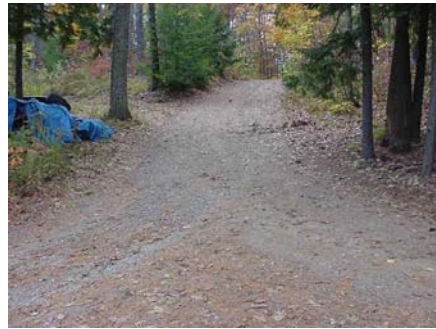
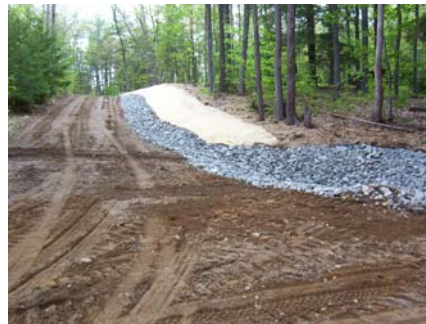
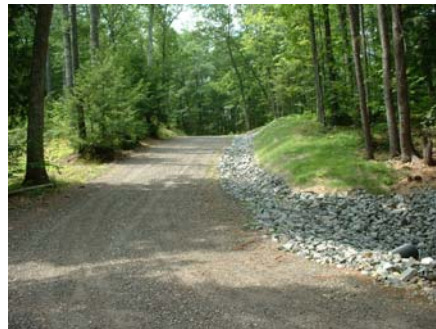
Private Road Sites: West Five/West 51

Roads were eroding and depositing sediment into Bauneg Beg Lake.

Sediment carries phosphorus that can lead to algal blooms in the lake if sites are left untreated.

Create a rock-lined ditch, rock-lined sediment basin, below-ground detention basin and reshape and re-surface both roads

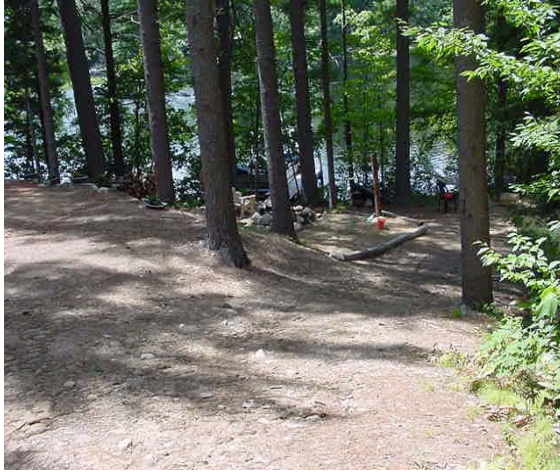
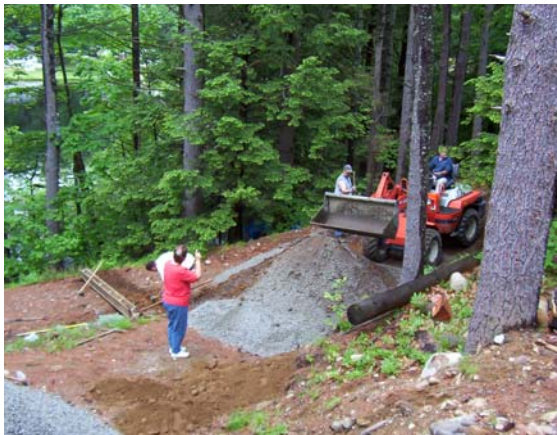
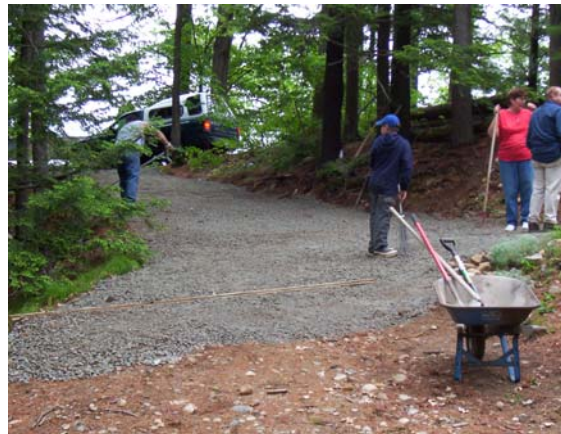
Residential Site: Demarco—Channel Lane

The Problem: Eroding Driveway and Embankment, Steep Slope.

The Solution: Reshape and Resurface the Driveway, Install Open Top Culverts, Install Roof Runoff Trenches.

- **Additional Plantings on Bank**
- **Erosion Control Mix on lower area**
- **Direct Water to Lower Culvert**

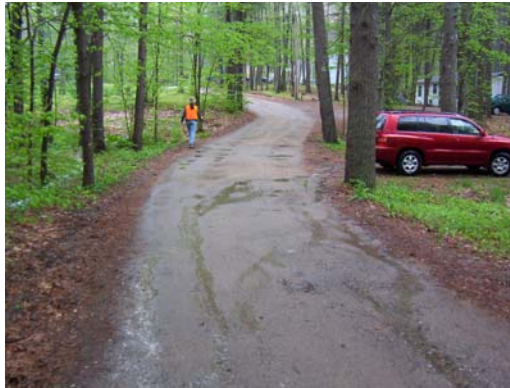
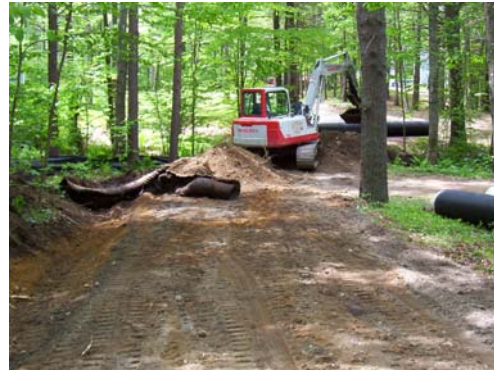
Private Road Site: Punky Parkway

The Problem: Eroding private road depositing excess sediment onto residential property and into adjacent stream.

The Solution: Install a grass-lined ditch and rock sediment basin, enhance turn-out, reshape and re-surface road.

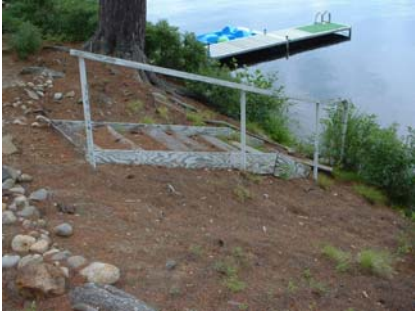
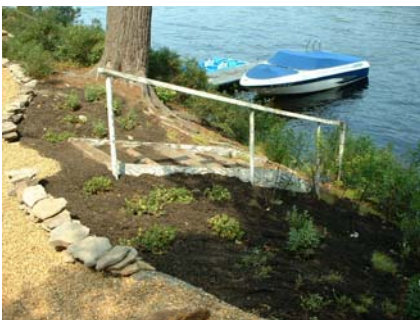
Residential Site: Jordan's—West 2

The Problem: Steep, eroding bank with little vegetation.

The Solution: Plantings on the bank, erosion control mix in areas of bare soil. Add stone to areas above slope.

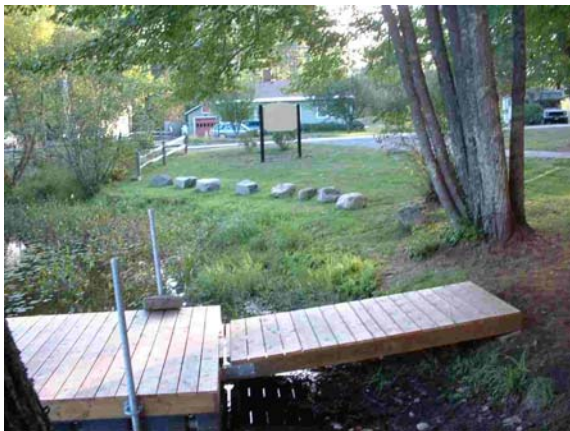
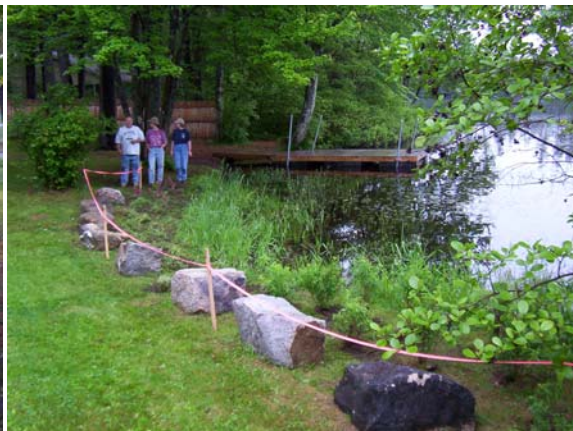
Vegetative Buffer: North Berwick Park

The Problem: Public access area lacks adequate vegetative buffer.

The Solution: Approximately 30 plants were added to enhance the buffer.

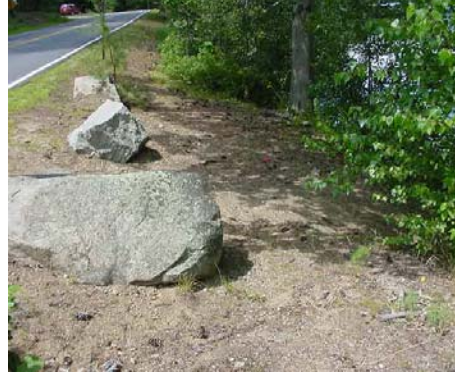
Shore Access: Morrell's Mill Road

The Problem: Foot traffic and runoff from the roadway has eroded area near the Grange.

The Solution: Install trench to catch runoff, plantings to enhance buffer and reduce erosion.

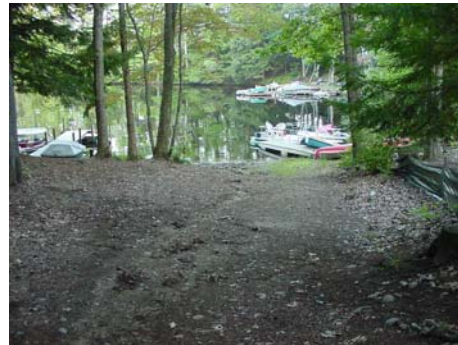
Boat Launch/Camp Road (Funds Permitting)

The Problem: Runoff from Camp Road and Boat Access creating a gully and draining into lake.

The Solution: Turnouts and open-top culverts (or speed bumps) on roadway, new surface material and turnouts on boat access.

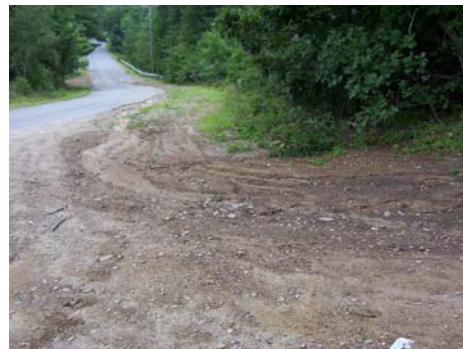
Town Road: Sand Pond Road

The Problem: Runoff from private road and Sand Pond Road causing eroding shoulders and excess sedimentation to the Great Works River (which flows into Bauneg Beg).
